# MSF5000 DIGITAL ERROR CODES

When the station detects an error, an error code appears in the Status display. This code is used to aid in the troubleshooting of the MSF5000. Error codes are differentiated from other MSF codes by illuminating all three decimal points of the Status display.

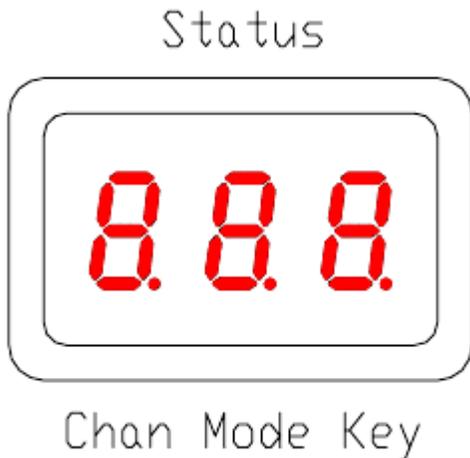
There are five different categories of error codes. The category is displayed in the left-most digit of the Status display. The type of error is represented in hexadecimal format in the two right-most digits of the Status display. Hexadecimal coding permits up to 256 possible error codes per category.

The figure below illustrates the error code format and how it is presented within the Status display.

The “Chan” digit displays the type of error:

- A = AUDIO ERROR
- d = DIGITAL ERROR
- E = OPERATIONAL ERROR
- o = TEST MODE ERROR
- U = UNDEFINED ERROR

The “Mode” and “Key” digits display the error code. Refer to the following tables for specific error code definitions.
